INSTRUCTIONS FOR CONTINUED AIRWORTHINESS

CESSNA 172 GROSS WEIGHT INCREASE STC SA2196CE

DOCUMENT: 17205GWI-ICA-1-REV0

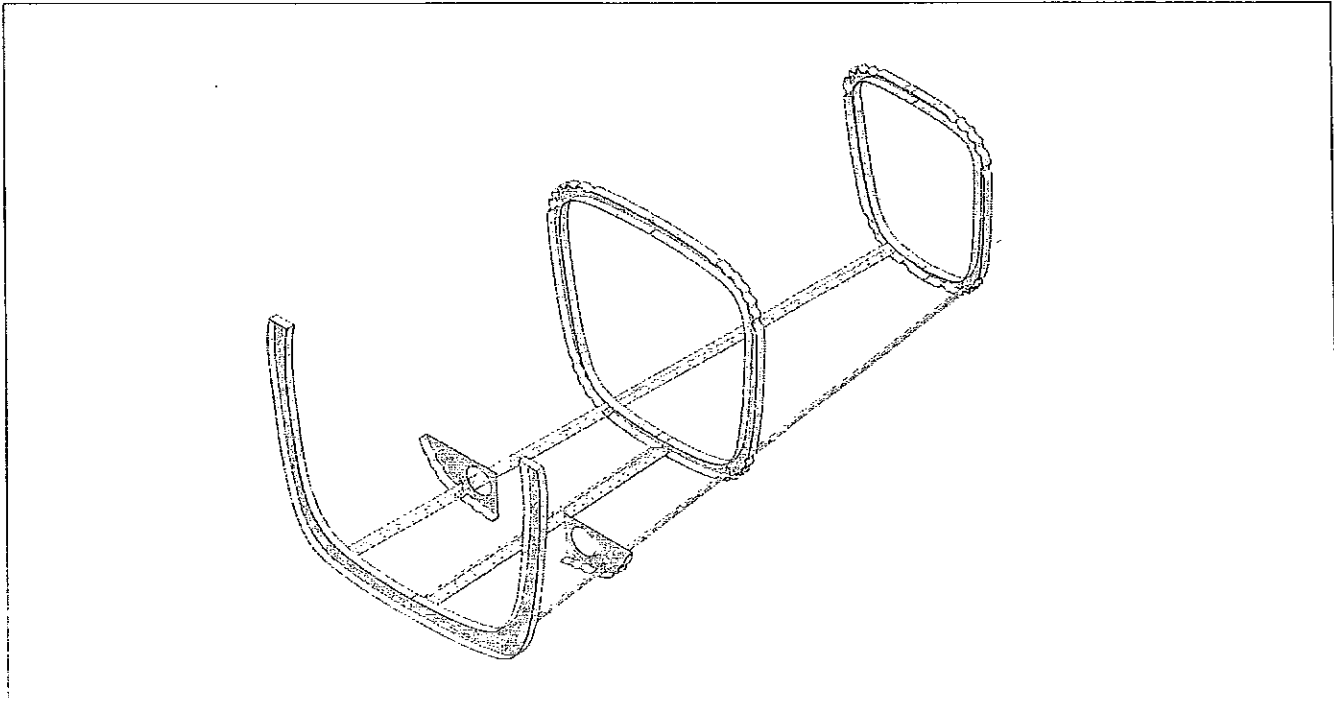
Figure 1 - Tailcone Stringer Installation

This modification consists of the installation of longitudinal stringers in the aft tailcone section on Cessna models 172 D thru 172 K. A center stringer (Cessna PN# 0512060-1) that runs from bulkhead station 108 to bulkhead station 142 is installed in conjunction with two other stringers (Cessna PN# 0512041-4 Right Side, Cessna PN# 0512041-5 Left Side) that run from bulkhead station 180 to bulkhead station 178.
